*** Residential Inspection Report ***

1122 Broadway
Your Town, TX

PROPERTY INSPECTION REPORT

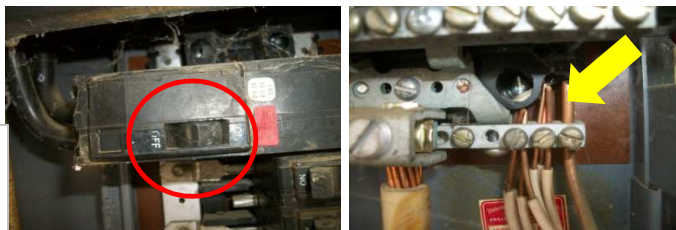
Comments:
 • The main disconnect circuit breaker is damaged and replacement is needed. This is considered a safety hazard and should be replaced as soon as possible. Refer to a qualified electrical contractor to make corrective repair.
 • Neutral wires are doubled or bundled together on the neutral bus bar. This is an unsafe condition that should be corrected by a qualified electrical contractor.

The breaker switch is

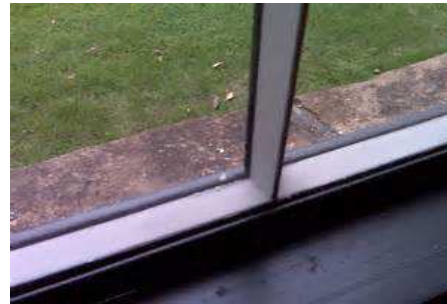
Windows: Cracked glass pane in family room, replacement needed.

Cracked glass pane

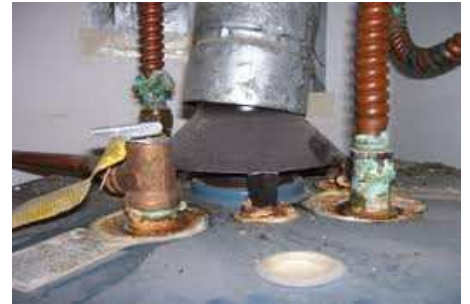
- Visible corrosion, this may be an indication of leakage, refer to a qualified professional for further evaluation and corrective repair(s) as needed.
- The exhaust vent pipe is loose and not properly secured to water heater, corrective repair needed.

Water heater
